Elevator Idler Fatigue Cracks

EFFECTIVITY**MODEL-** Ranger R7**SERIAL NO:** 10131-10227

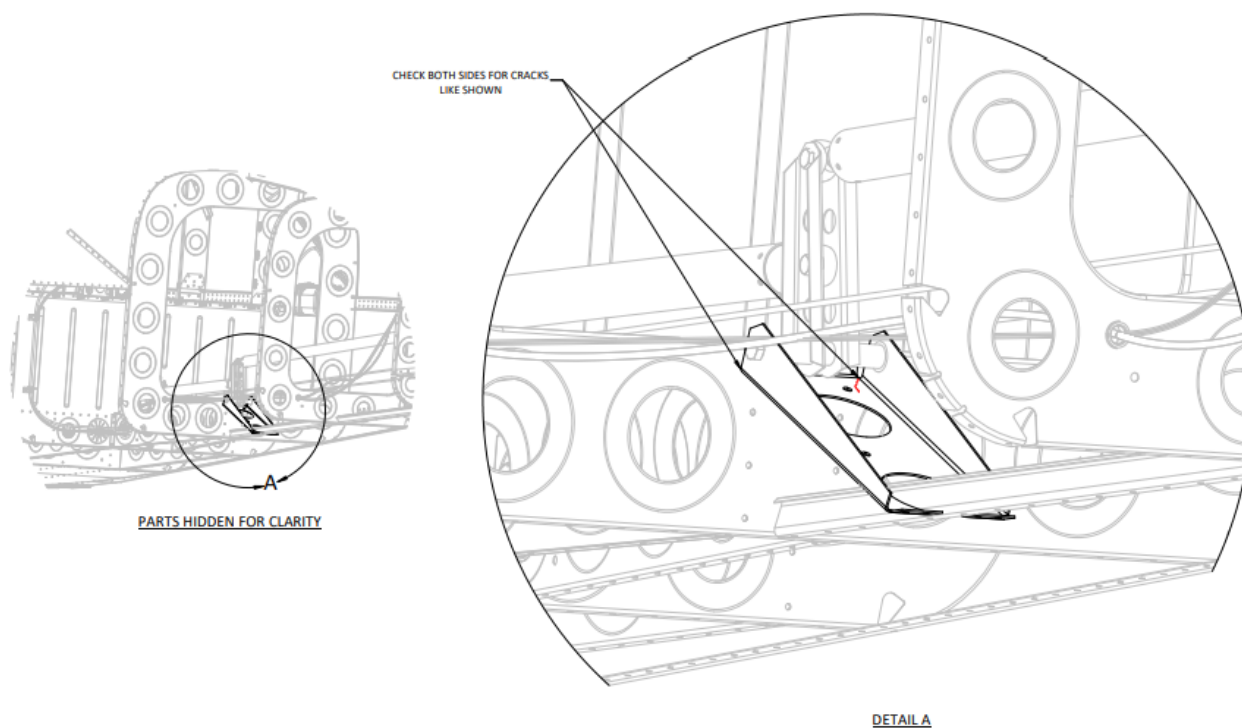
Fatigue cracks have been reported in the field on the bracketry supporting the elevator pushrod idler assembly. This is due to high loads from the elevator pushrod fatiguing the bracket through cyclic loading. It is also believed that corrosion of the idler also contributes to this issue. If a crack continues to propagate without proper attention, this could lead to slop in the elevator control system and possibly failure of the supporting bracketry.

Inspect bracket and fuselage ribs for cracks. Also note on condition of idler assembly.

Inspect the critical flanges as shown in Figure 2 and Figure 3. If any cracks are present, replace parts with upgraded design.
