**DATE RELEASED**

Nose landing gear leg vendor material defect

**EFFECTIVITY****MODEL-R7****SERIAL NO:** 10196-10228**Synopsis:**

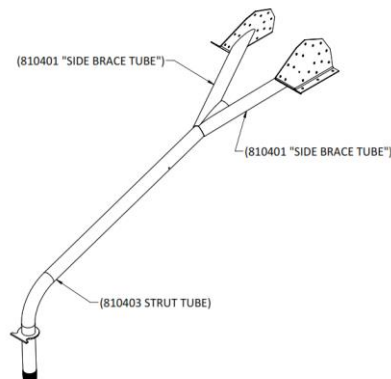
**Figure 2: 812601 Nose Landing Gear Weldment**

The portion of the weldment in question is the shorter, 810401 side brace tubes shown in Figure 2 (not the 810403 main strut tube). The 810401 tubes are supplied to Vashon Aircraft from a third party that performs the cope cut operation. Vashon Aircraft has discovered that the third party fulfilled an order with an unconfirmed percentage of parts made from material that does not conform to the 810401 drawing. The non-conforming material does not exhibit the necessary allowable strength requirements and is not heat treatable. While a certification of conformance and material certifications were supplied from the third party, non-conforming parts still entered our inventory. The weldments passed the heat treat quality check because the strength validation gets performed on the 810403 main strut tube.

- If either one of the 810401 tubes do NOT register on the HRC scale, then the part is non-conforming and the nose landing gear weldment needs to be replaced.
- If both 810401 tubes register on the HRC scale, then the part is conforming and does not need to be replaced.

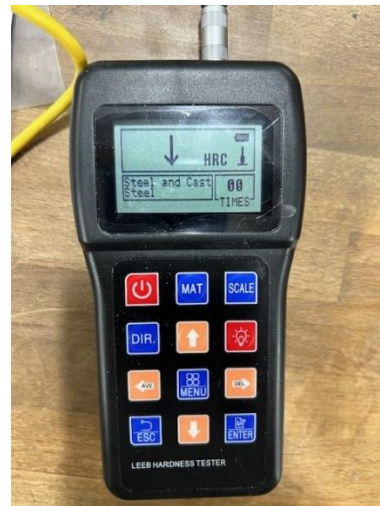
**Figure 8:** Non-registered hardness

**Step 5:** Place the impact device base directly on top of the bare metal that was sanded. *NOTE: It is important that the axis of the device is placed perpendicular to the tube and that you and the device are stable during the test.* Push the release button on the top of the device. You will hear the plunger impact the tube and bounce back a few times. The display will then show the hardness reading. If it registers on the HRC scale, a number will be present. If it does *not* register, then a downwards arrow will be present with no number (see Figure 8).

If either one of the 810401 tubes do not register on the HRC scale after testing multiple times, then the nose landing gear leg needs to be replaced. Contact Vashon Aircraft for parts procurement and install per the aircraft maintenance manual.
