Nose Fork Fatigue Cracks

EFFECTIVITY**MODEL-** Ranger R7**SERIAL NO:** ALL AIRCRAFT WITH THE 810601 NOSE FORK (10131-10186)**REASON**

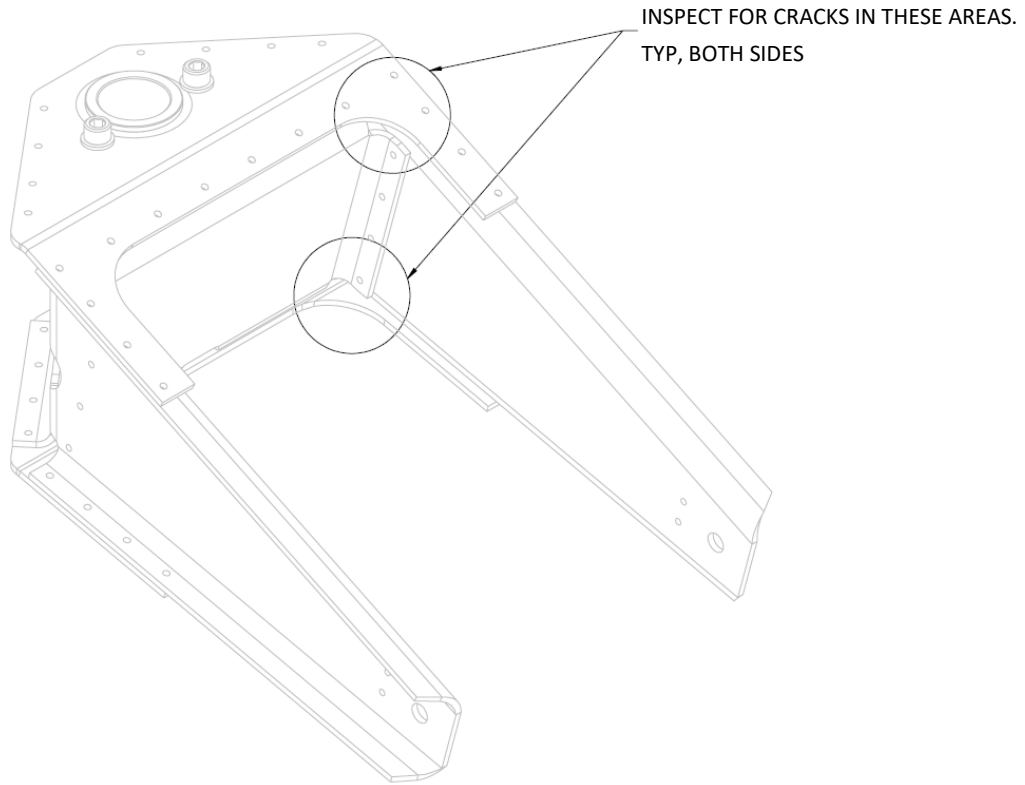
INSPECT FOR CRACKS IN THESE AREAS.
TYP, BOTH SIDES

Inspect nose fork for cracks in the areas shown in Figure 1 and Figure 2. If any cracks are present, DO NOT continue flying—Contact Vashon Aircraft for corrective action until a subsequent bulletin is released.
