**DATE RELEASED**

Nose landing gear leg vendor material defect

**EFFECTIVITY****MODEL-R7****SERIAL NO:** 10196-10228**Synopsis:**

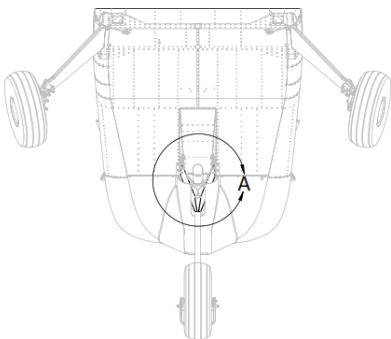
**Figure 1: Belly View**

**Step 1:** Locate the 810401 side brace tubes on the nose landing gear leg weldment under the belly of the aircraft and near the exhaust collector.

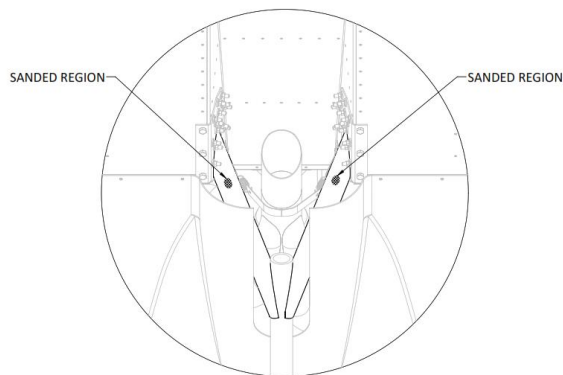
**Figure 3: Detail A**

**Step 2:** Using a piece of sandpaper, sand off the white powder coat until roughly a ¼ inch circle of bare metal is visible in an accessible spot on the 810401 side brace tube. (see Figure 3).

**Step 7:** Coat the exposed, bare metal with a high gloss, white paint (*Only applicable if both 810401 tubes are conforming and the weldment does not need to be replaced*).

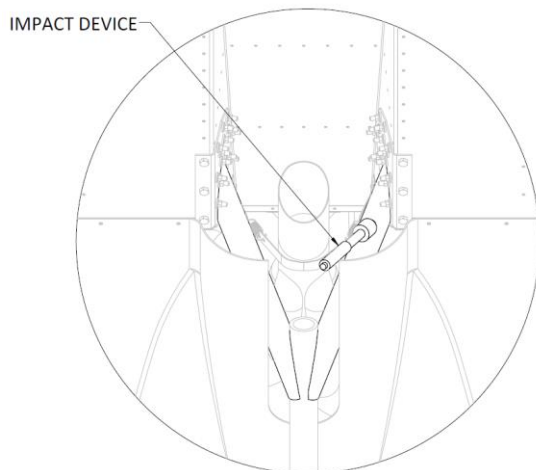
**Figure 7:** HRC Test on Tube

**Step 5:** Place the impact device base directly on top of the bare metal that was sanded. *NOTE: It is important that the axis of the device is placed perpendicular to the tube and that you and the device are stable during the test.* Push the release button on the top of the device. You will hear the plunger impact the tube and bounce back a few times. The display will then show the hardness reading. If it registers on the HRC scale, a number will be present. If it does *not* register, then a downwards arrow will be present with no number (see Figure 8).

\*If a hardness value does not show on the display, test a few more times to make sure the device is mounted firmly on the surface of the tube and not pointing at an angle. (Each impact test requires the device to be triggered by sliding the sleeve down, as described in Step 4).

If either one of the 810401 tubes do not register on the HRC scale after testing multiple times, then the nose landing gear leg needs to be replaced. Contact Vashon Aircraft for parts procurement and install per the aircraft maintenance manual.
